REPORT OF MARINE SURVEY

Condition Survey for Swiss Certification

"SAMURI"

2007 PDQ Antares 44i

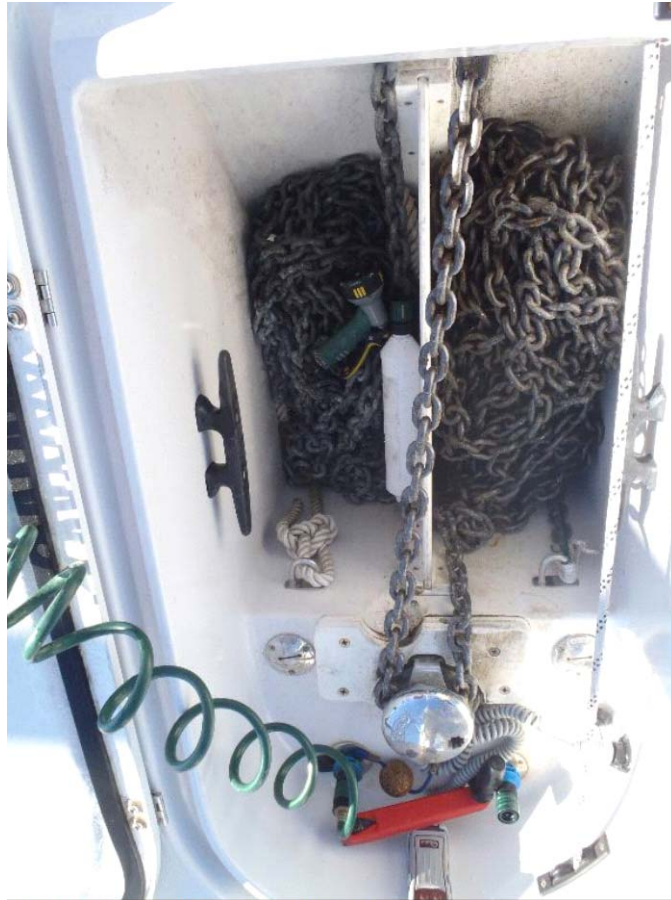
Quick 12 Volt Horizontal Windlass

Quick 12 volt DC horizontal windlass, securely mounted.

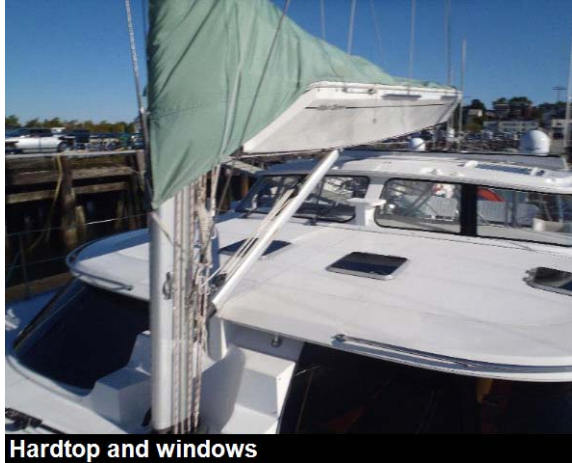
Hardtop and windows

| 4.11 Cabin house window(s): | Large wrap around fixed acrylic windows in the main salon: No visible signs of water intrusion around the frames. The lenses were clear. |

FRP hard top, secure and functional. Full bridge deck enclosure in Above Average condition.

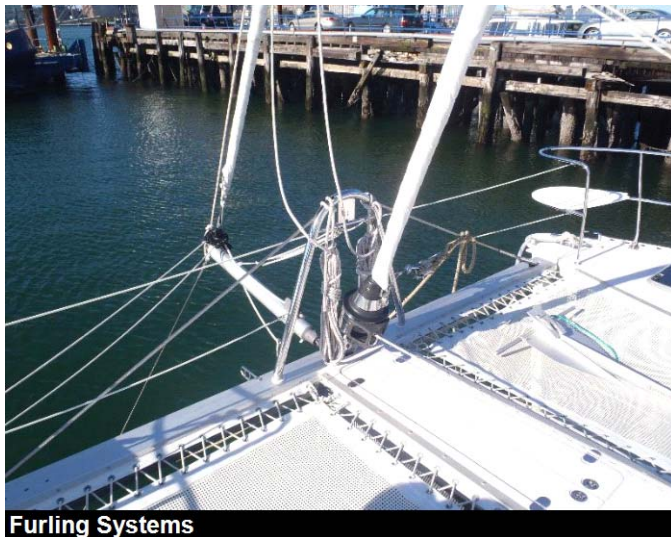
Furling Systems

Harken genoa and screecher furling systems, secure and appeared functional with no signs of damage or wear.

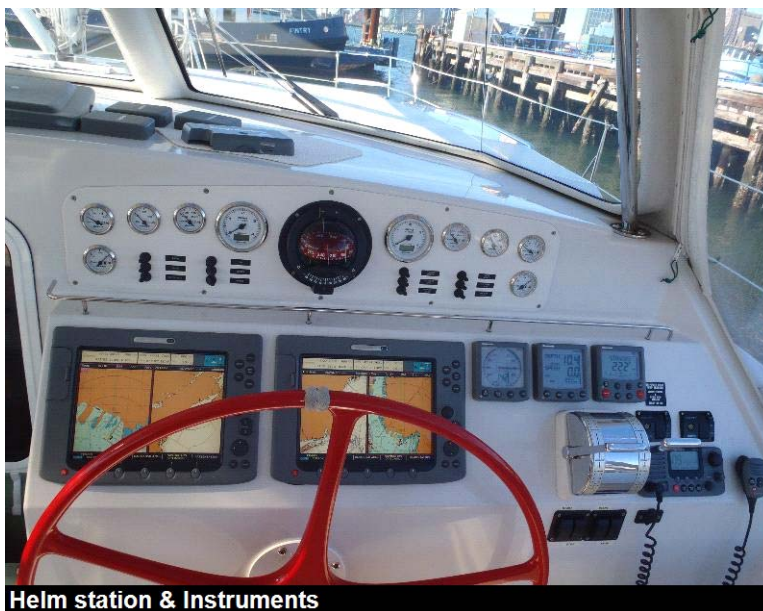
Helm station & Instruments

6" Ritchie Powerdamp compass mounted on the helm station bulkhead, appears functional, clear lens, full fluid. Hand bearing compass.

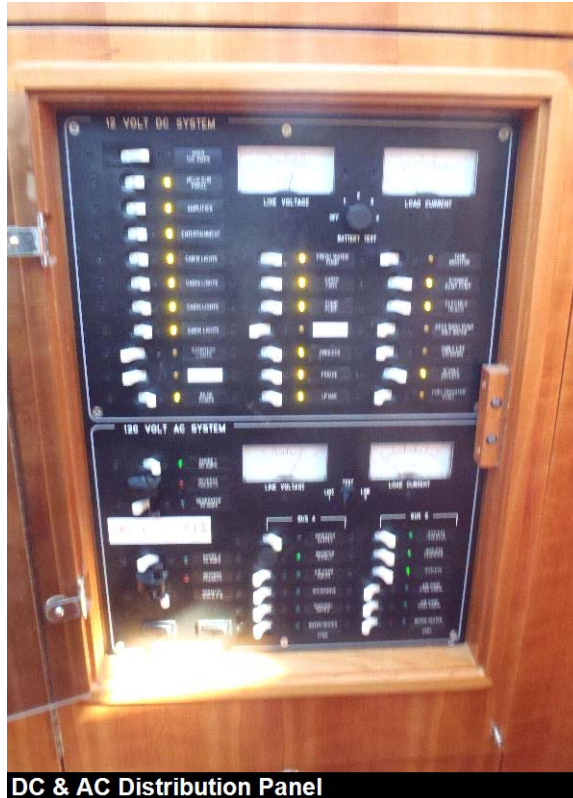
DC & AC Distribution Panel

- 9.1 *D.C. Voltage system:* 12 Volt system.
- 9.2 *No. / Size of batteries:* Seven (7): Four (4) deep cycle house batteries; three (3) engine batteries. All securely stored in FRP boxes and/or trays with secure straps.
- 9.3 *Battery selector (on/off) switch:* Blue Sea Systems rotary type switch, secure and functional.
- 9.4 *Battery monitor:* xantrex Link 10 digital unit, functional.
- 9.5 *Distribution panel:* Clear labeled and properly wired 12 volt DC panel with functional switch activated indicator lights. Secure captive wire connections. The color coded and clearly labeled wires are well supported and bundled.

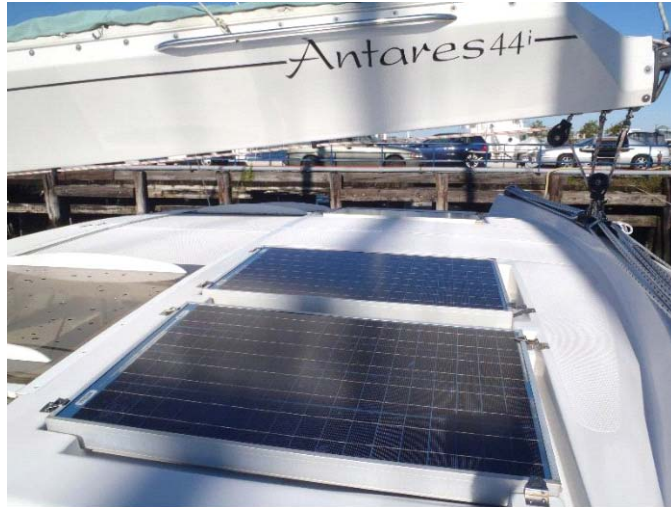
Four (4) 60 Watt Solar Panels

Four (4) large 60 Watt Solar panels securely mounted on the FRP hardtop.

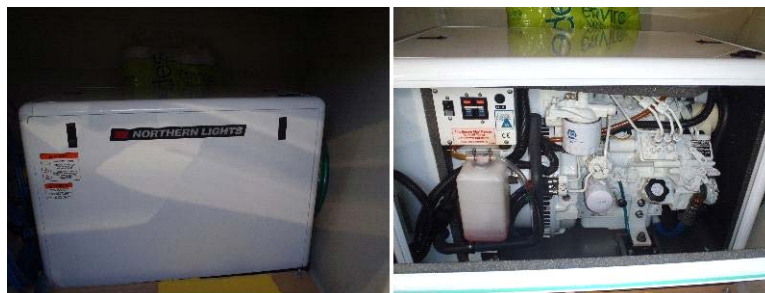
Northern Lights 6 kw generator

| 9.23 Number / Type: | One (1) diesel 6 kw Northern Light model 7H3L generator securely mounted in and sound proofing box. |

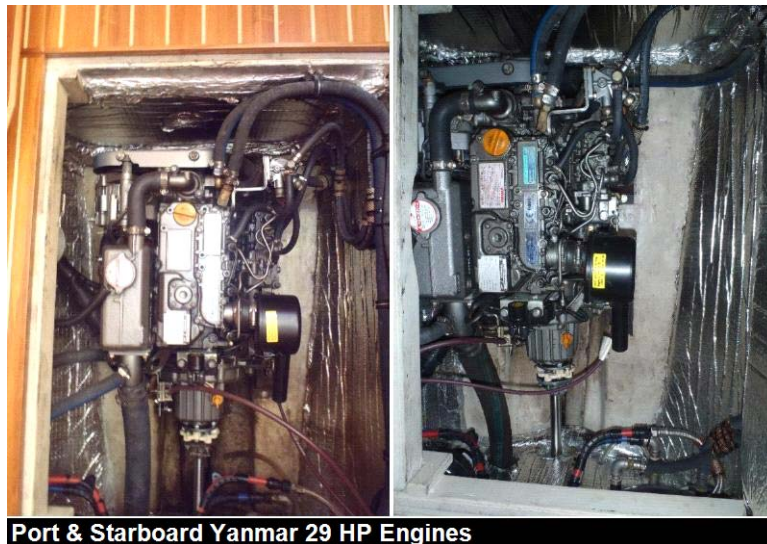
Port & Starboard Yanmar 29 HP Engines

Two (2) inboard naturally aspirated Yanmar 29 HP Model # 3YM30 diesel engines.

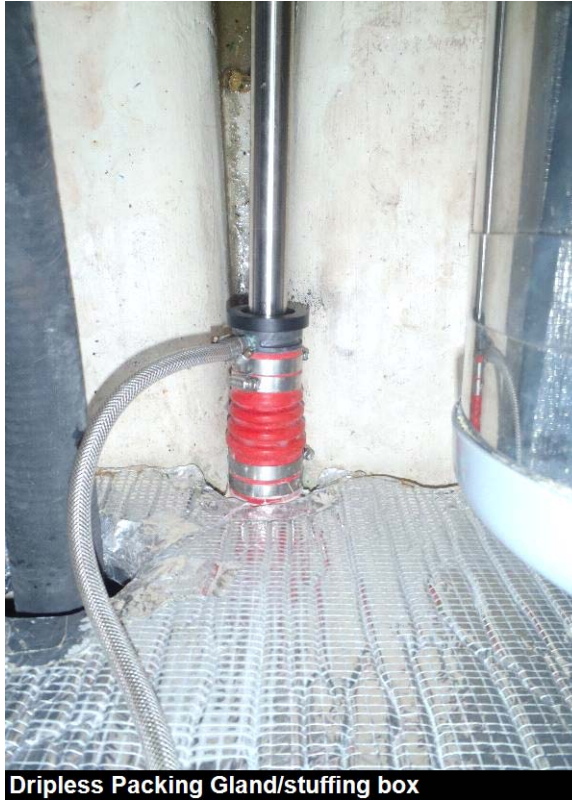
Dripless Packing Gland/stuffing box

Packless shaft seal systems. Bellows and carbon collars are secure and appears functional.

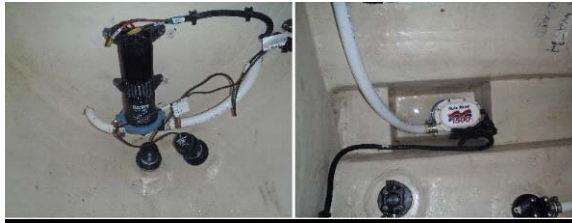
Bilge pumps

Two (2) manual/automatic Rule 1500 gph 12 volt DC bilge pumps securely mounted and operational. The hoses and clamps were in good condition. One (1) Whale Gulper 220 pump. One adequately sized bucket.

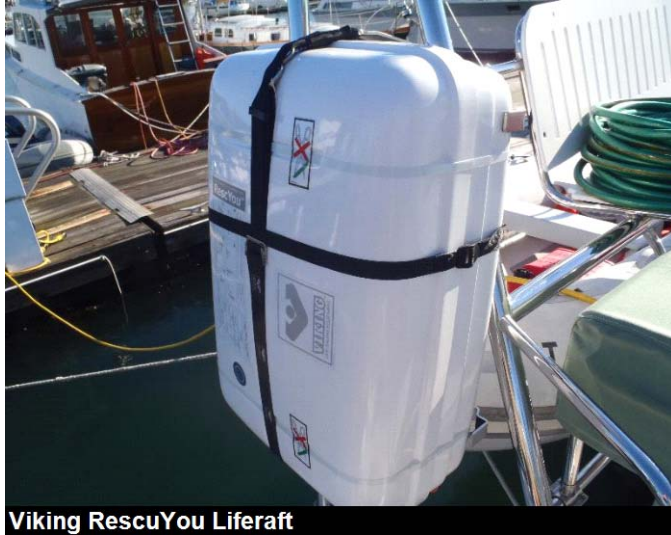
Viking RescuYou Liferaft

Viking Rescu You Pro six (6) person liferaft. Serial number 11254060. Painter line 10m. Type 1 Group A. Located on the starboard aft side rail in a FRP container. Date of Commissioning: 03-2010. Recommended next servicing: 03-2013. Current Certification of Compliance onboard and available from Viking Life Saving Equipment.

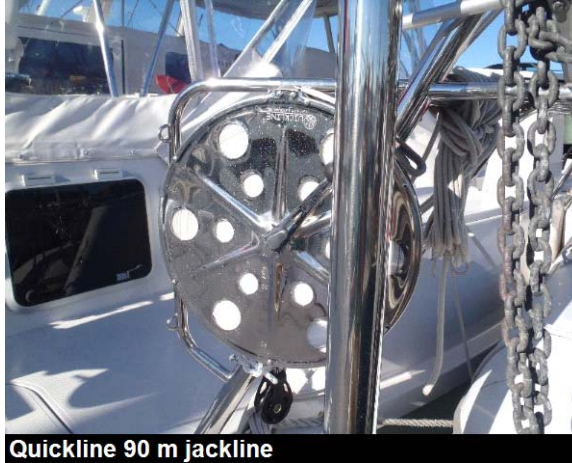
Quickline 90 m jackline

Quickline heavy duty 90 m jackline and rescue strap in "like new" condition located on a stainless steel drum securely mounted on the port aft rail.

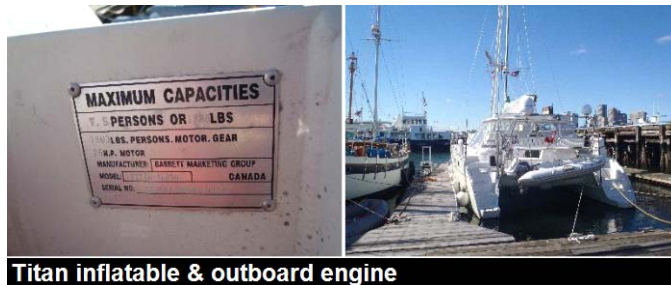
Titan inflatable & outboard engine

Titan Model AL 350 hard (FRP) bottom inflatable tender in good condition (like new) hung securely on the transom from stainless steel davits. Hull Identification Number: NZ - XWI-20842H708
Yamaha 15 HP outboard engine in good condition.
