## CONDITION REPORT (HULL EXTERIOR)

10 February 2015

Catamaran **SAMURI**

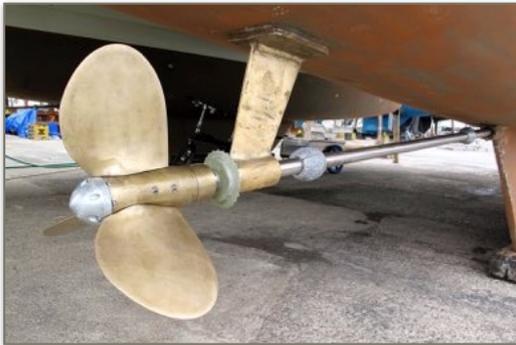
**Photo one**

At the time of the 02 February inspection the port and starboard P-bracket Cutless bearings had been replaced. No undue movement of the shafts in the new bearings was noted.

There was appreciable movement of the stainless steel propeller shafts in an up and down direction in the P-bracket Cutless bearings. The owner advised that he intends to have Whangarei Engineering fit new Cutless bearings prior to relaunching.

Replace the port and starboard P-bracket Cutless bearings

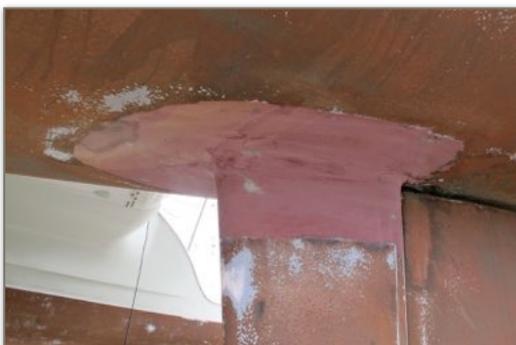
**Photo two**

At the time of the 02 February inspection the port side rudder skeg to hull joint had been ground-out and filled.

There was no signs of movement at the hull to keel joints or at the starboard hull to skeg joint. A hairline crack was noted in the cove on the out-board side of the port skeg to hull joint. The skeg was vigorously shaken from side to side and no undue movement between the skeg and hull was noted. The owner advised that at a previous haul-out at Norsand Boatyard he had the Norsand boatbuilders grind-out and re-cove the starboard joint and intends to do the same with the port cove prior to relaunching.

Grind out and re-cove the port side skeg to hull joint

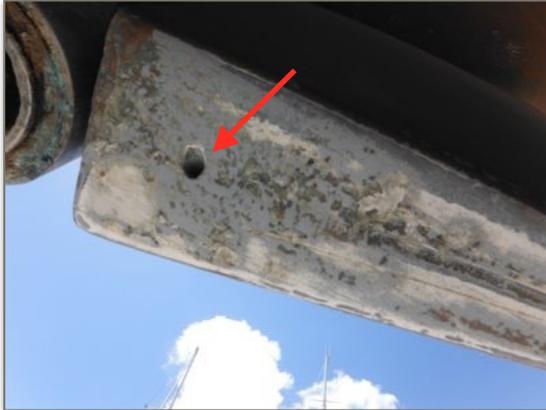
**Photo three**

At the time of the 02 February inspection, as a further check on whether there had been water ingress into the starboard rudder core through the rudder stock to blade joint, a 5mm diameter hole was drilled into the underside of the rudder blade to a depth of approximately 50mm. There was no evidence that the core was wet and the owner subsequently filled and sealed the hole. The port rudder was not checked.

The arrow indicates the location of the exploratory hole drilled into the underside of the starboard rudder blade. No signs of water in the area of the hole indicated that there had not been any water ingress into the rudder core through the rudder stock.

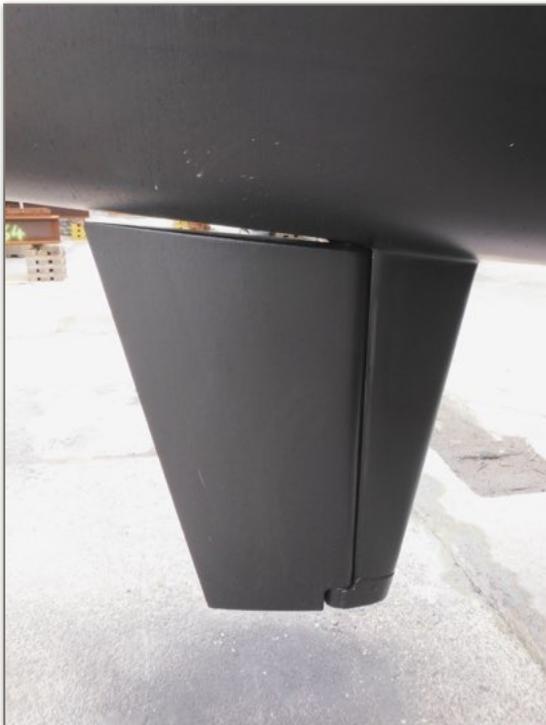
**Photo four**

The photo shows the port rudder after antifouling (10 February 2015).

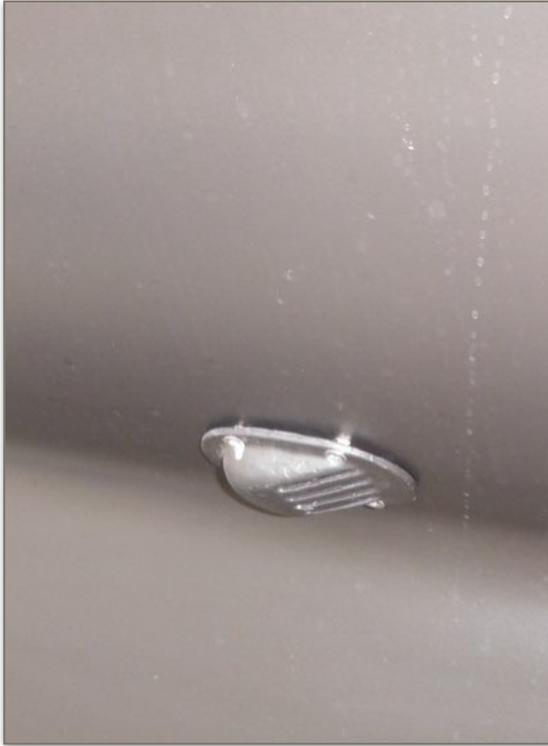
**Photo five**

At the time of the 02 February inspection the owner had removed all of the through-hull strainers and was in the process of filling some of the strainer fastening holes in the hull with epoxy filler in preparation for re-bedding and re-fastening the strainers onto the hulls into position over the through-hull fittings. At the time of the 10 February inspection it was noted that the strainers had been re-fitted (*refer to photo five on page 4 below*).

Photo five shows the strainer - located starboard hull outboard amidships - refastened to the hull. When observed it was noted that the strainers they were not fully mated up to the hull, but were securely fastened.

Through-hull fittings appeared to be secure and in good serviceable condition. It was recommended to the owner that he check the through-hull fitting strainers to ensure that they are secure to the hulls prior to relaunching.

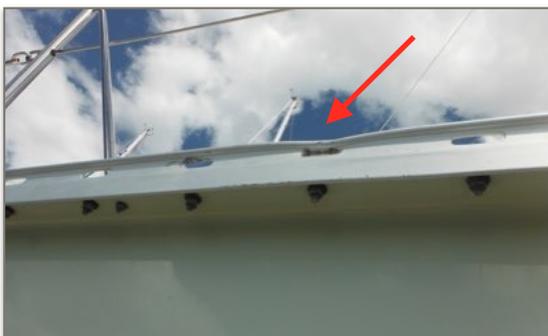
**Photo six**

The arrow indicates an area of minor damage on the aluminium toe rail, starboard side aft of amidships.

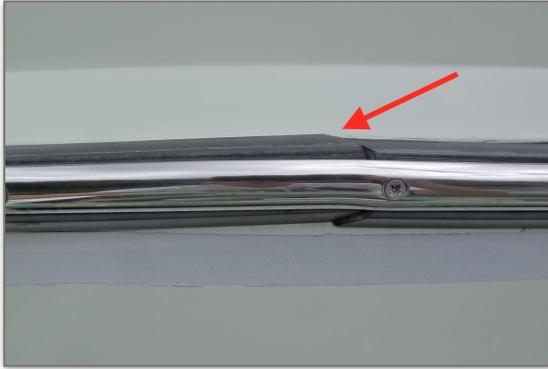
**Photo seven**

The arrow indicates an area of damage to the rub-rail on the starboard side aft of amidships.

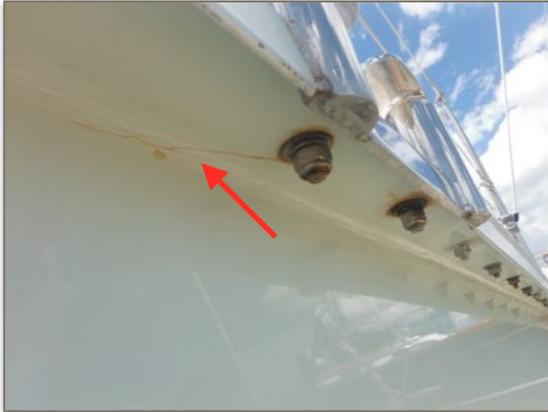
**Photo eight**

The arrow indicates one of a number of hairline cracks in the gelcoat on the hull to deck joint, hull flange, adjacent to a fastening bolt on the port side forward of amidships.

It was also noted that a number of the stainless steel fastening bolts (that fasten the toe rail to the deck edge and fasten the hull to deck joint) are showing signs of light surface rust staining. It is recommended that the fastenings and the area on the underside of the hull to deck joint are monitored and, if necessary, attended to during scheduled maintenance.

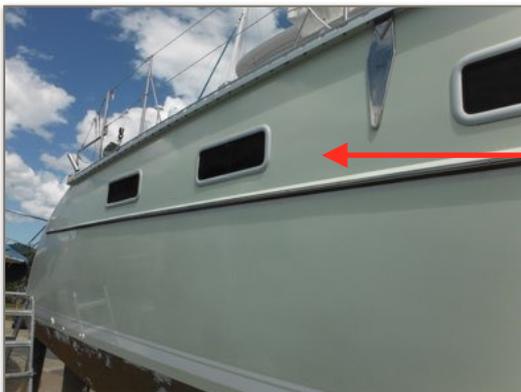
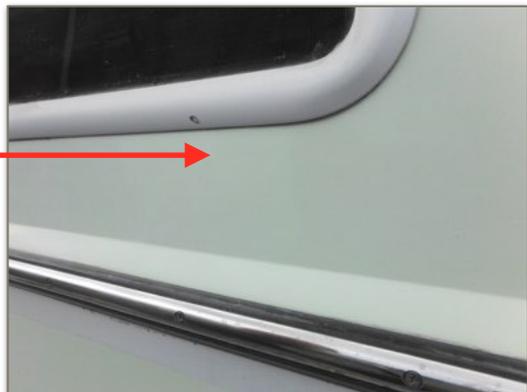
**Photo nine**

At the time of the 10 February inspection it was noted that the owner had carried out several small gelcoat repairs to minor abrasions in the gelcoat on the hulls and a repair to damage caused by the anchor chain chafing through the FRP anchor rode tube, which is located on the port side of the central bridge. A small crack in the gelcoat - in the area of a previous gelcoat repair located on the starboard out board side under the window aft of the shroud chain plate - had also been repaired and the hulls buffed and polished (*refer to photo nine below*).

The arrow indicates the location of the area described above.

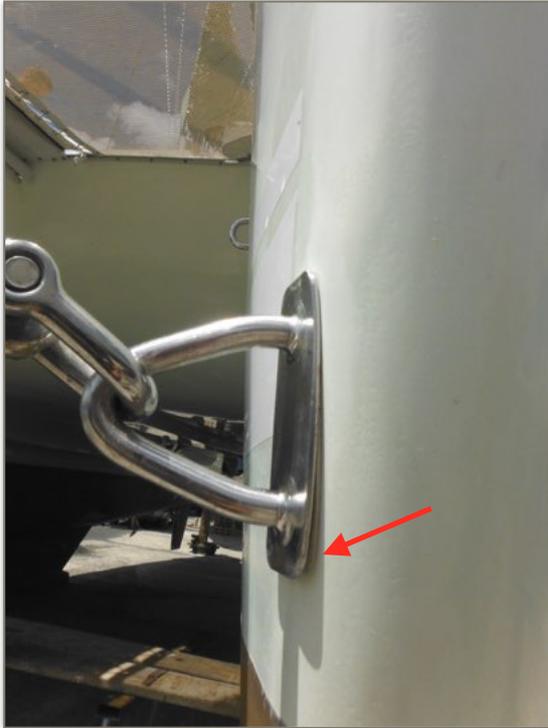
**Photo ten**

It was noted that the lower sections of the prod stay attachment fittings, which are fastened to the inboard sides of each bow above the waterline, have pulled away slightly from the hull surfaces due to the upward pull from the stays. The owner advised that he had been aware of this for some time and that he had not noticed any movement or any seepage on the inside the hulls through the fastenings securing the fittings. It is recommended that the fittings are monitored and attended to if necessary (*refer to photo ten below*).

The arrow indicates the gap between the hull and the lower section of the port side prod stay attachment fitting. It may be desirable to replace both the port and starboard fittings with ones that are better designed to take the angle of the load from the prod stays.
